RE: Cottage Cleanup and Bat Entry Modifications Per Mitigation Recommendations at the Navarro-by-the-Sea Specific Plan Study Area Navarro River Redwoods State Park Mendocino County, California

This is a brief report describing our cleanup and bat roost enhancement activities on 10/28 and 10/29/09 in the two cottages located just west of the Navarro Inn. These activities were conducted in order to enhance the habitat value of the two small wood structures for Townsend's big-eared bats (*Corynorhinus townsendii*), a California Special Concern (CSC) species that is known to roost in small numbers (1 or 2 in the Inn, one in each Cottage), at various times throughout the year.

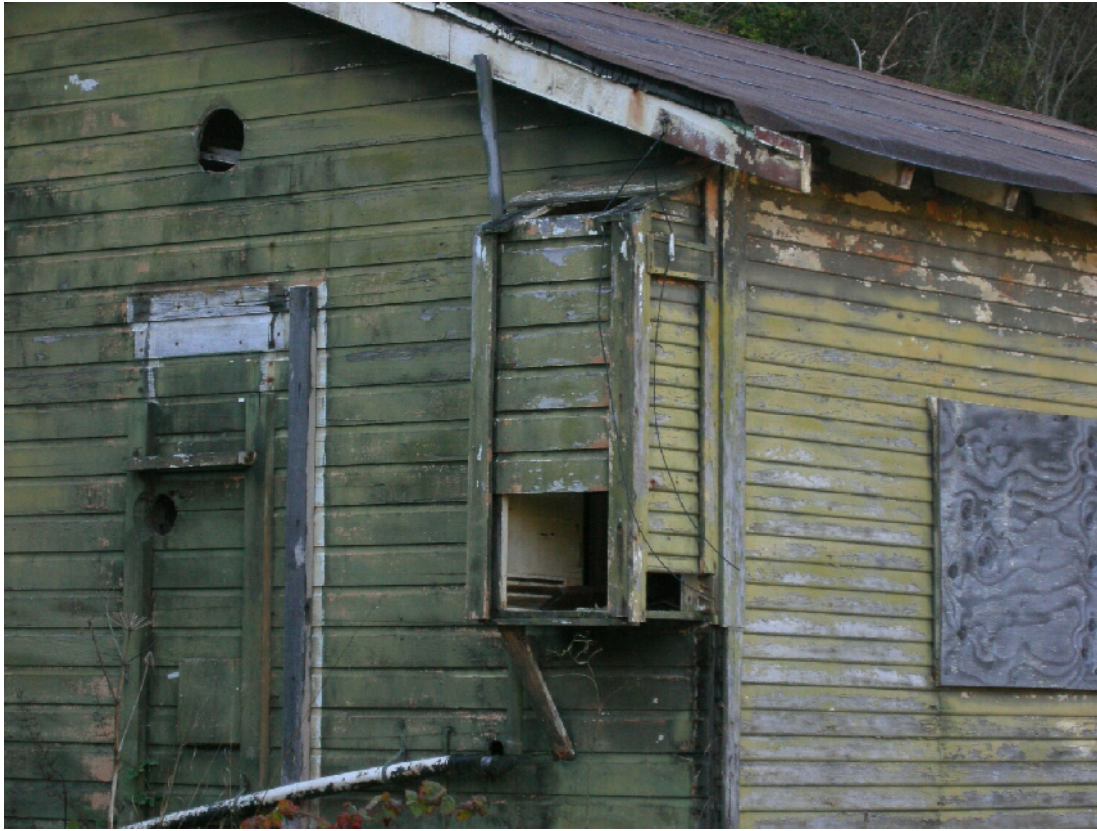
Fig. 1.
Example of
prior condition
of California
Cooler, East
Cottage. Roof
missing,
structure
failing,
openings at
bottom provide
easier access
and viewing by
public.

Attached to the outside of each cottage is a small extension in the former kitchen areas known as California Coolers. These appear to provide the primary entry openings for *C. townsendii*, and were modified and reinforced to relocate the existing bat entry location about 24" higher, make viewing and entry by the public more difficult, strengthen each structure, and provide better protection from rain.

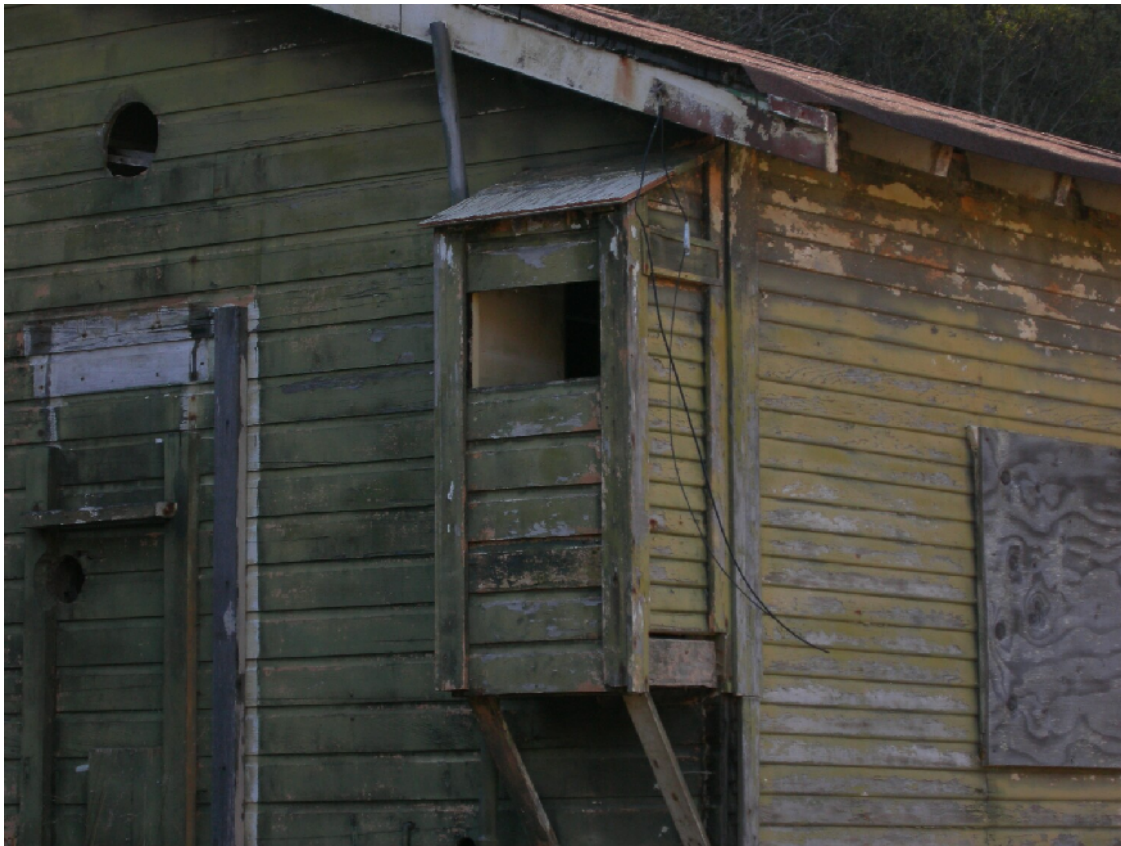
Fig. 2. East
Cottage
California
Cooler after
reconstructi
on and
modification
to
strengthen,
make more
watertight,
and improve
access for
C.
townsendii.

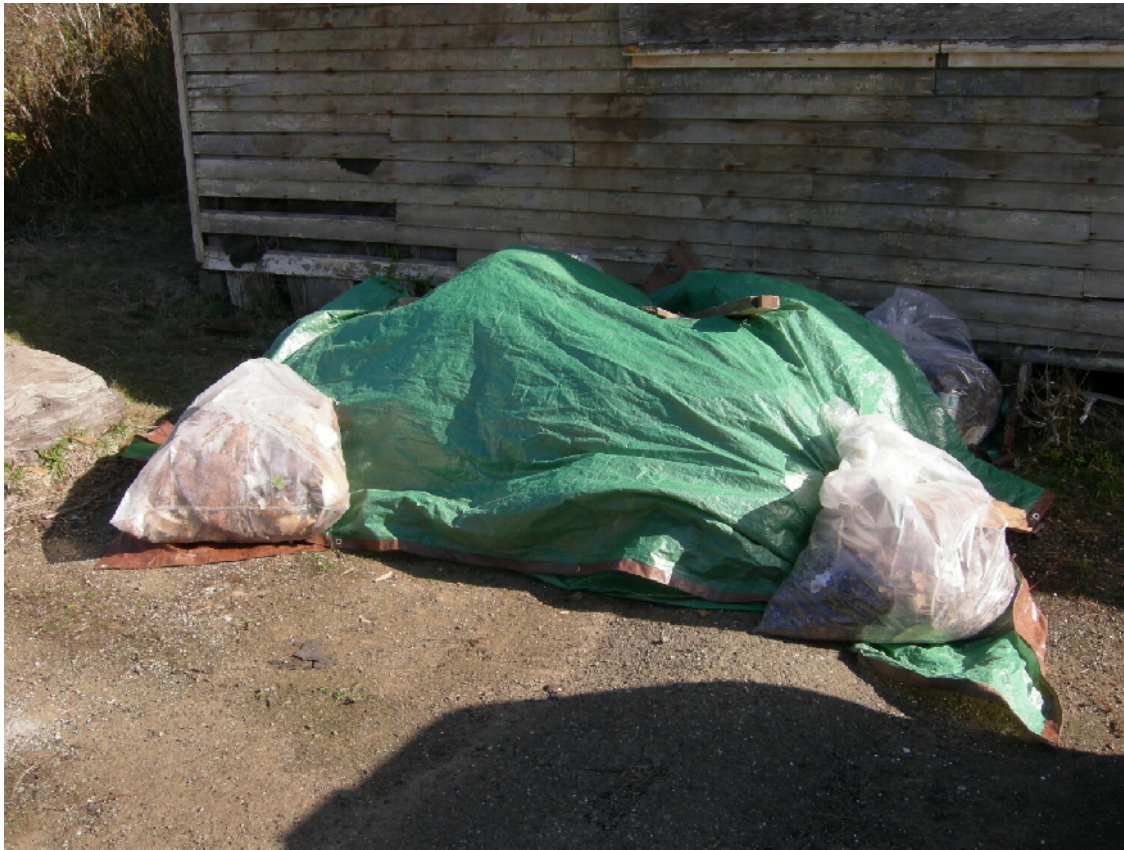
Fig. 3. Several hundred pounds of woody debris, rodent nests and fecal matter, and other debris removed from cottages and disposed of by CDPR.

All debris was piled on a tarp and covered overnight with another tarp, both supplied by California Department of Parks and Recreation (CDPR), who removed the debris on 10/28/09.
