Delineation of Potential Jurisdictional Wetlands under Section 404 of the Clean Water Act & California Coastal Act

Navarro River Redwoods State Park Albion, Mendocino county California

California State Parks, Mendocino District

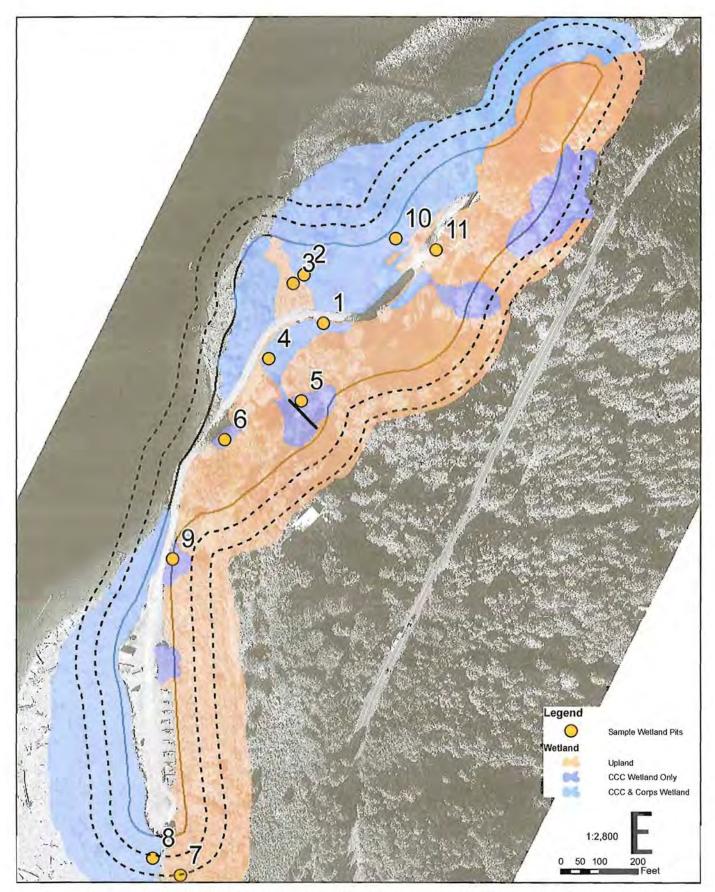
Figure A1. Navarro-by-the-Sea Wetland Delineation Map - Navarro River Redwoods State Park. Upland areas, California Coastal Act (CCC) wetlands, and both CCC wetlands and the US Army Corps of Engineers (Corps) wetlands are shown based on wetland parameters (soil, vegetation, & hydrology) from sample pit locations.

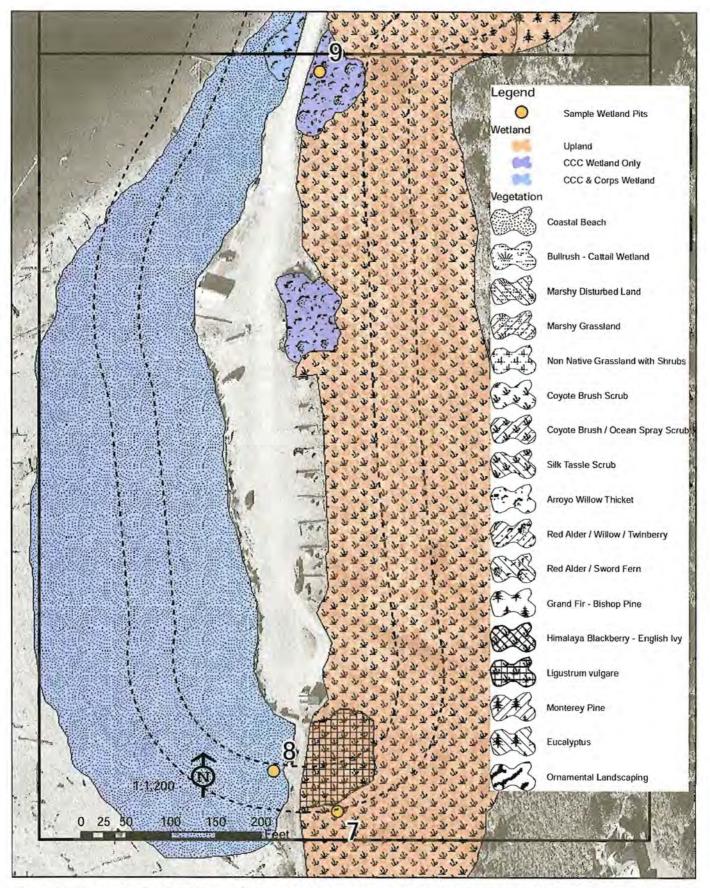
Figure A2 Navarro-by-the-Sea Wetland Delineation Map - Navarro River Redwoods State Park - Sheet 01. Upland areas, California Coastal Act (CCC) wetlands, and both CCC wetlands and the US Army Corps of Engineers (Corps) wetlands are shown based on wetland parameters (soil, vegetation, & hydrology). The sample pits may represent several vegetation classes delineated on the map.

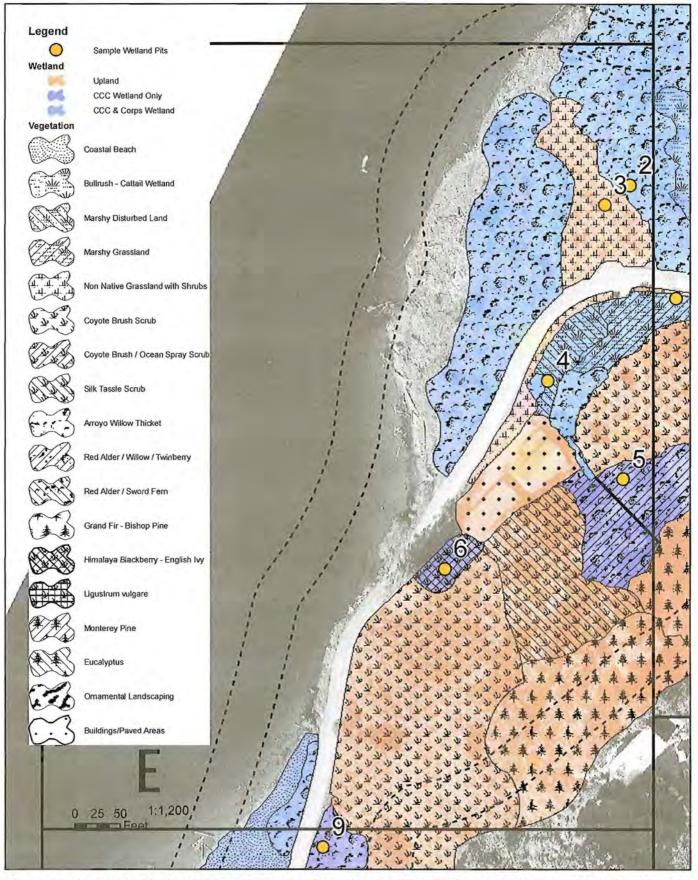
Figure A3. Navarro-by-the-Sea Wetland Delineation Map - Navarro River Redwoods State Park - Sheet 02. Upland areas, California Coastal Act (CCC) wetlands, and both CCC wetlands and the US Army Corps of Engineers (Corps) wetlands are shown based on wetland parameters (soil, vegetation, & hydrology). The sample pits may represent several vegetation classes delineated on the map.

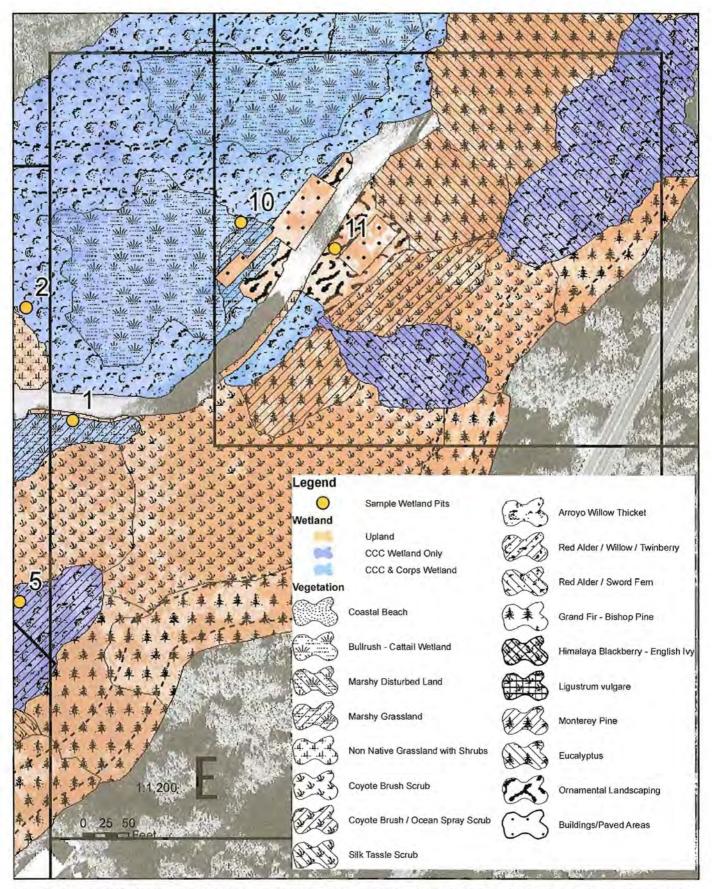
Figure A4. Navarro-by-the-Sea Wetland Delineation Map - Navarro River Redwoods State Park - Sheet 03. Upland areas, California Coastal Act (CCC) wetlands, and both CCC wetlands and the US Army Corps of Engineers (Corps) wetlands are shown based on wetland parameters (soil, vegetation, & hydrology). The sample pits may represent several vegetation classes delineated on the map.

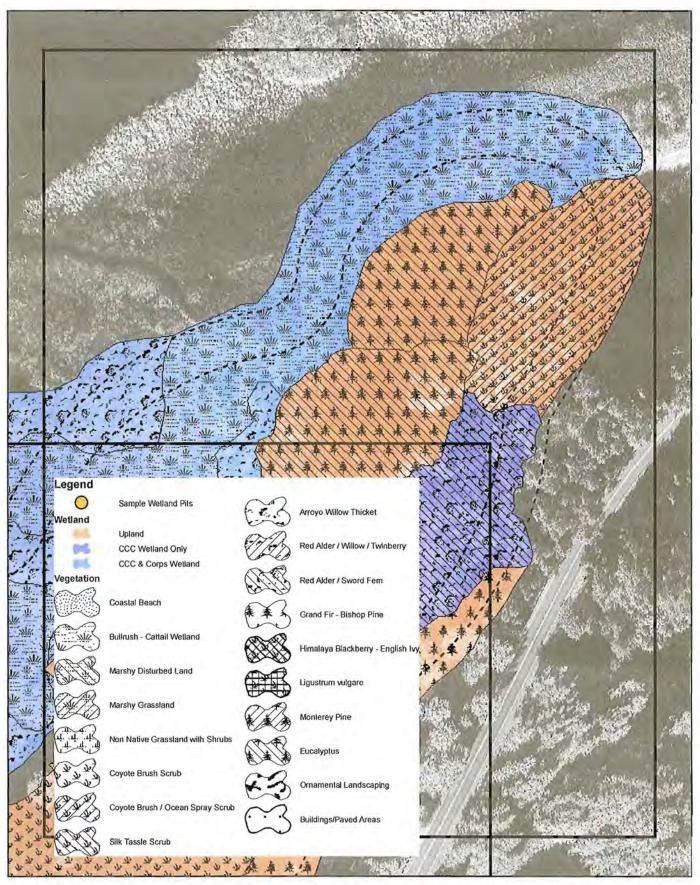
Figure A5. Navarro-by-the-Sea Wetland Delineation Map - Navarro River Redwoods State Park - Sheet 04. Upland areas, California Coastal Act (CCC) wetlands, and both CCC wetlands and the US Army Corps of Engineers (Corps) wetlands are shown based on wetland parameters (soil, vegetation, & hydrology). The sample pits may represent several vegetation classes delineated on the map.

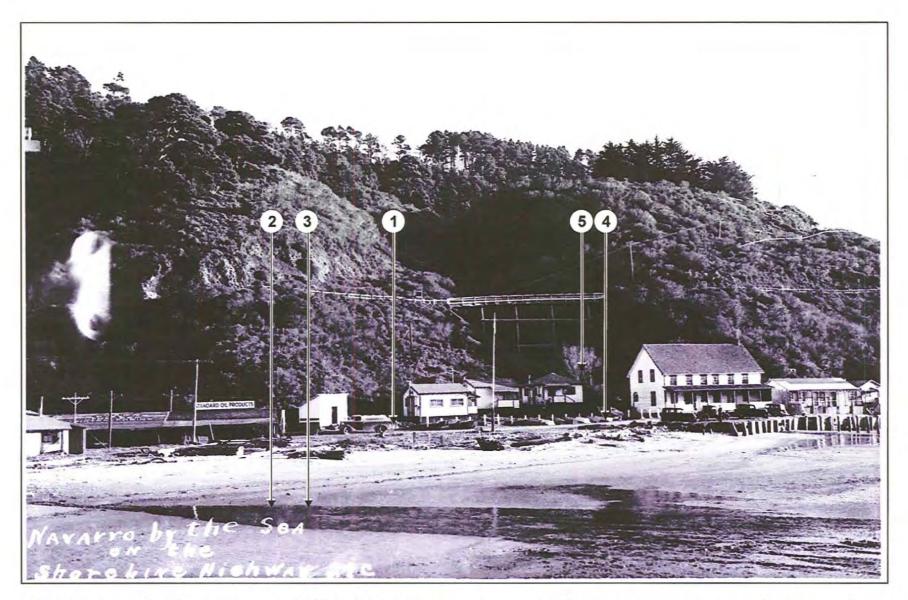
Figure B1. Navarro Inn Historic Photograph with Wetland Sample Pits. Approximate sample pit locations are shown on the photograph and correspond to the sample pit numbers on the data sheets.

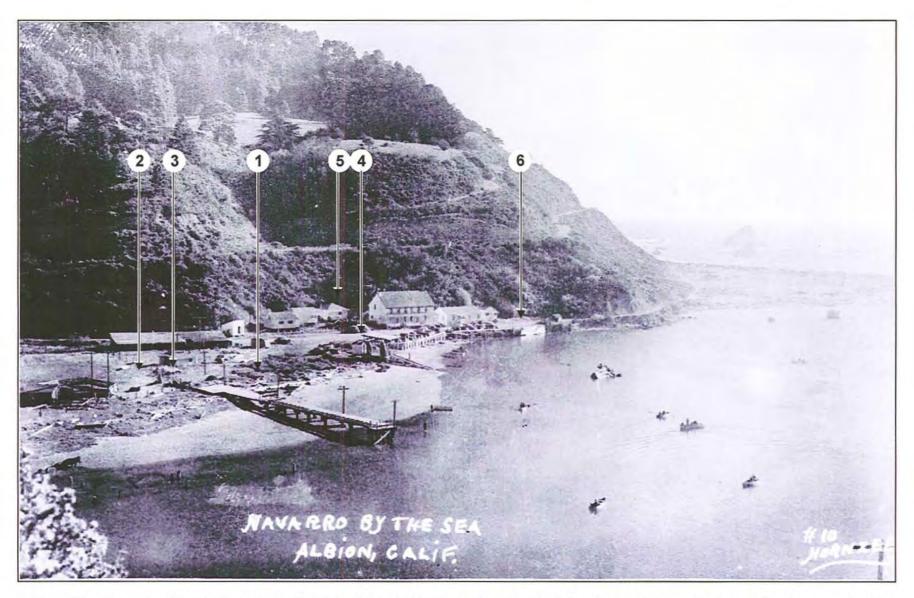
Figure B2. Navarro Inn Historic Photograph with Wetland Sample Pits. Approximate sample pit locations are shown on the photograph and correspond to the sample pit numbers on the data sheets.

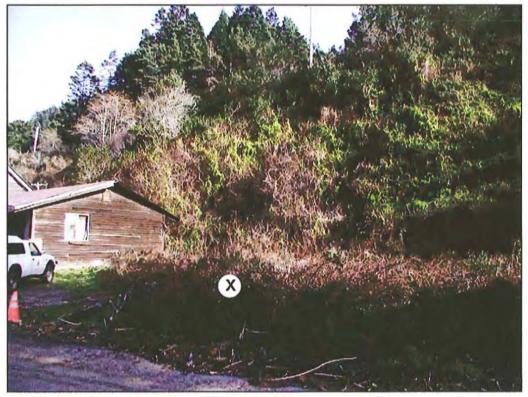
Figure C1. General Area of Sample Pit #6. Typical vegetation is shown in the photograph. See corresponding datasheet. White circle with "X" indicates general area of sample pit.

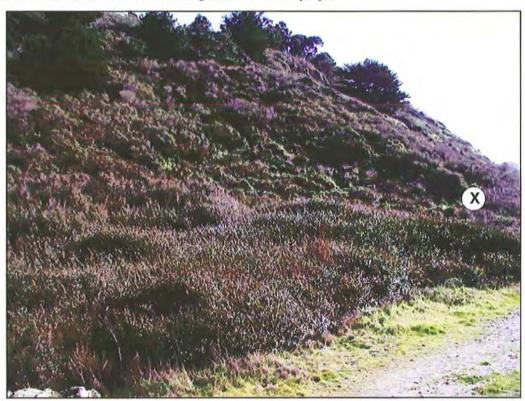
Figure C2. General Area of Sample Pit #7. Typical vegetation is shown in the photograph. See corresponding datasheet. White circle with "X" indicates general area of sample pit.

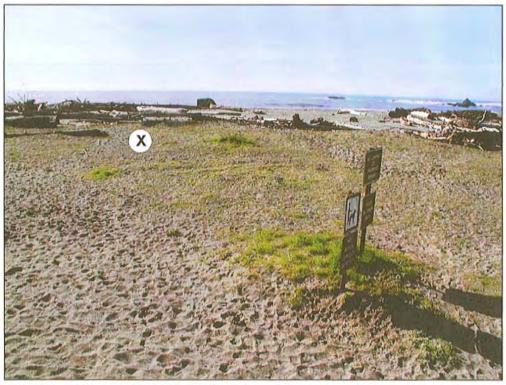
Figure C3. General Area of Sample Pit #8. Typical vegetation is shown in the photograph. See corresponding datasheet. White circle with "X" indicates general area of sample pit.

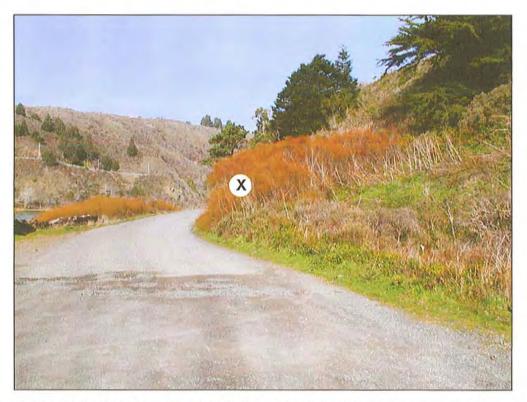
Figure C4. General Area of Sample Pit #9. Typical vegetation is shown in the photograph. See corresponding datasheet. White circle with "X" indicates general area of sample pit.
