Drainage and Flood / Storm Investigation

Navarro-by-the-Sea Center Navarro River Redwoods State Park

I.L. Welty & Associates 703 N. Main Street Fort Bragg, CA

Revised December 2008

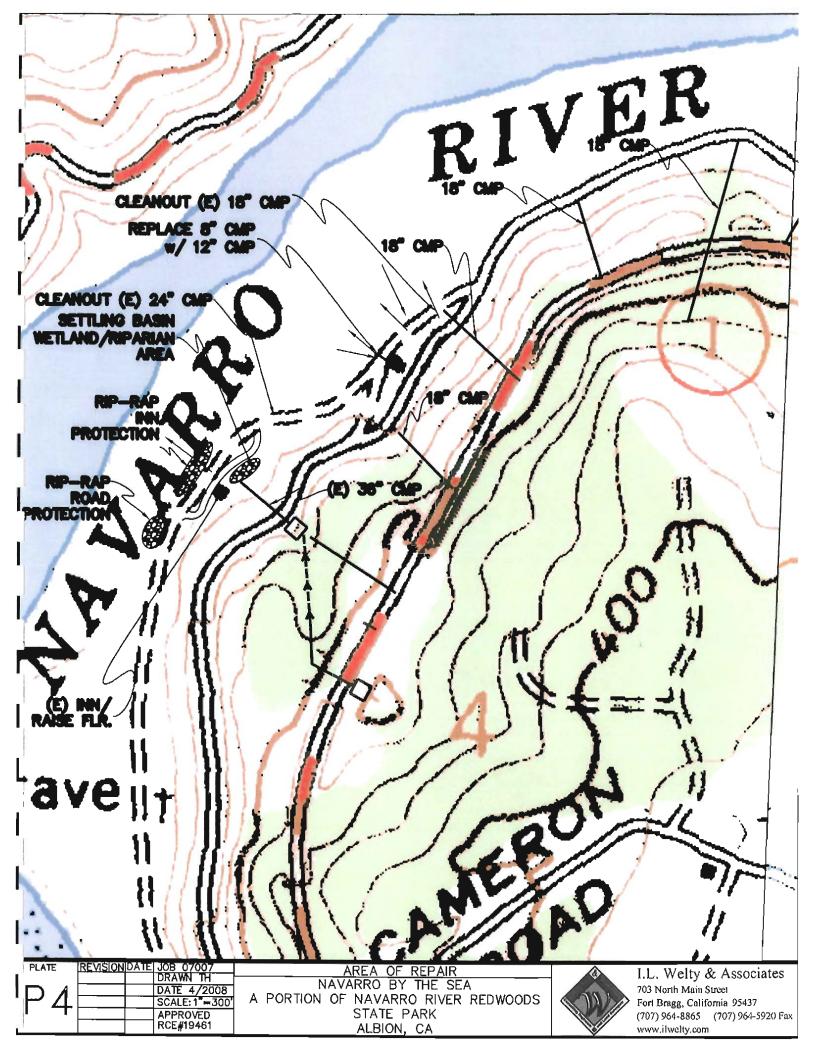
See Plate P2 for area map

AREA DISCHARGE

Damage Area	Area Access	Tc min.	I 10 inch/hr	I 100 inches / hr	Run-off C	Q10	Q100
*							
1	13.0	20	1.6	2.5	0.3	6.24	9.75
2	7.1	20	1.6	2.5	0.3	3.41	5.33
3	2.5	20	1.6	2.5	0.3	1.20	1.88
4	7.0	20	1.6	2.5	0.3	3.36	5.25
5	2.5	20	1.6	2.5	0.3	1.20	1.88
6	5.3	20	1.6	2.5	0.3	2.54	3.98
7	2.2	20	1.6	2.5	0.3	1.06	1.65
8	2.9	20	1.6	2.5	0.3	1.39	2.18
9	2.2	20	1.6	2.5	0.3	1.06	1.65
